BLACKSTONE RIVER BASIN  
HOPEDALE, MASSACHUSETTS

HOPEDALE POND DAM  
MA 00624

PHASE I INSPECTION REPORT  
NATIONAL DAM INSPECTION PROGRAM

JUNE 1979

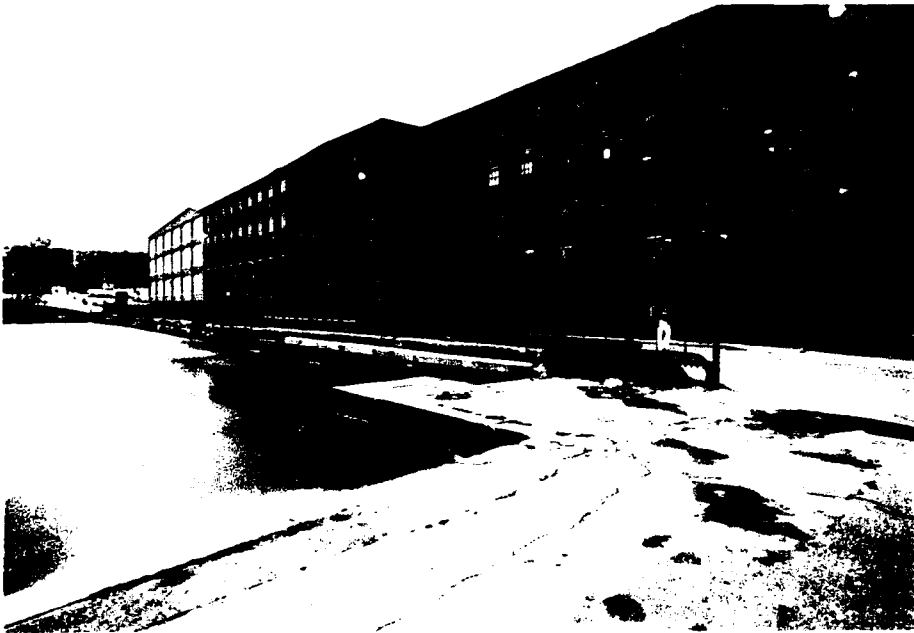
1. OVERVIEW OF DAM FROM RIGHT ABUTMENT.

The intake for fire protection water at the right abutment of the dam as shown in Photos 1 and 8 is in good condition. Several cracks are present in the top slab which should be sealed to prevent future deterioration.

- (6) Minor rusting of the railings is present along the walkway.
- c. Appurtenant Structures - The roadway bridge over the spillway, as shown in Photo 1 is in fair condition. Erosion of concrete has taken place at the bridge piers, especially near the right side. The underside of the deck exhibits spalling on the upstream right side and reinforcement is exposed.

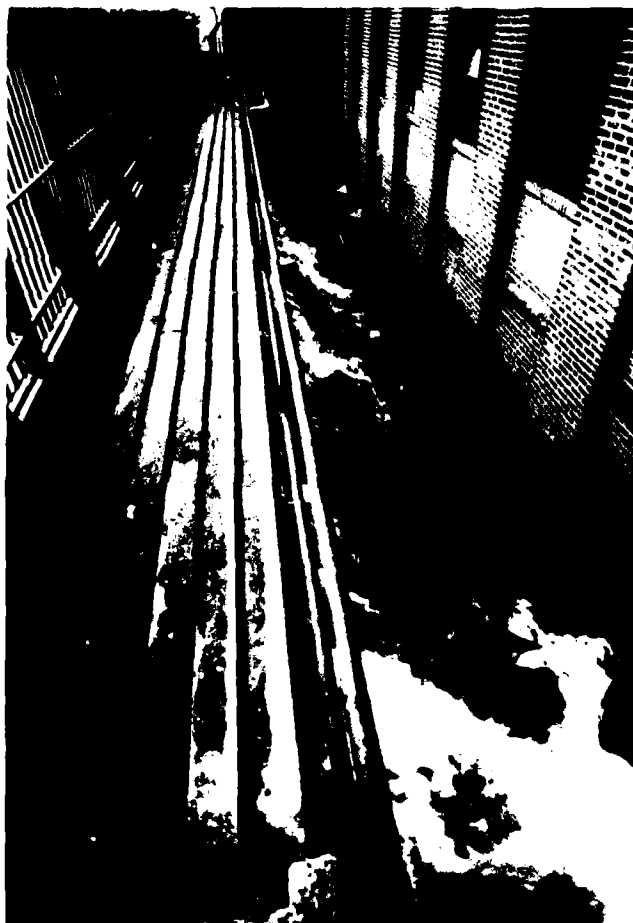
3. DOWNSTREAM FACE OF SPILLWAY AND DISCHARGE CHANNEL INLETS BENEATH BUILDING. FLASHBOARDS ACCESS WALKWAY WITH HAND-RAIL ALSO SHOWN.

- (2) Remove debris and reset displaced riprap at the bottom of the spillway cascade. Fill any remaining voids in the cascade with riprap.
- (3) Perform minor maintenance work including touch-up painting of rusted spots on the walkway railing, removal of debris from flashboards, lubricating and checking reservoir drain gate, sealing of concrete cracks at the fire portection intake and removal of vegetation and patching of concrete at the dam's upstream concrete wall.
- (4) Expand the existing operational procedure to delineate the specific areas of the dam to be viewed during the weekly checks of the dam, the routine maintenance to be performed on the dam and the establishment of warning systems and emergency preparedness plans.

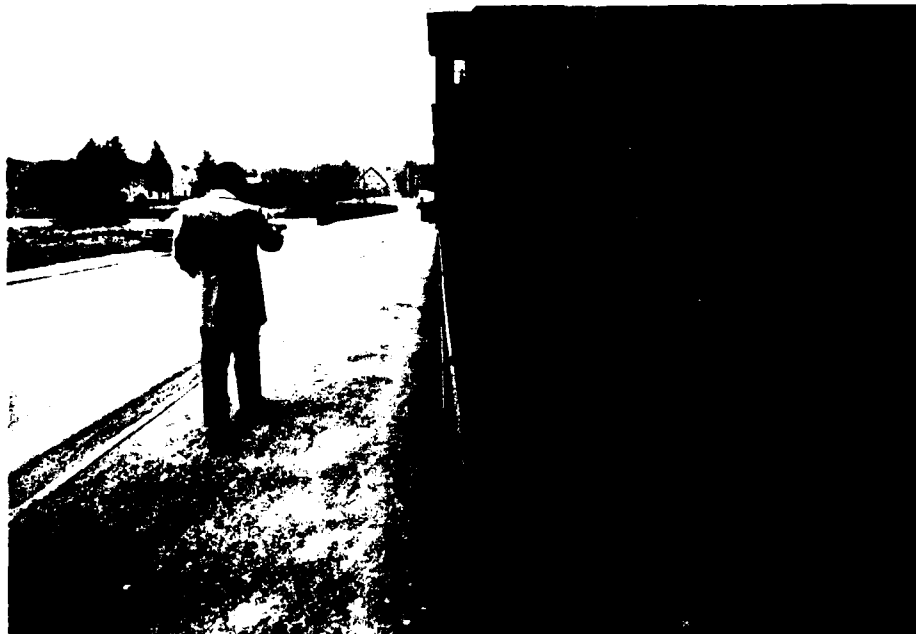
5. VIEW OF DRAINAGE TROUGH LOCATED ALONG THE RIGHT DOWNSTREAM EDGE OF DAM CREST.
